GROUP	MODEL
ELE	2018-2022MY Stinger (CK)
NUMBER	DATE
255	June 2022

## TECHNICAL SERVICE BULLETIN

**SUBJECT: DYNAMIC BENDING LIGHT DTC B232509/B232609 - MOISTURE ABSORBENT & BRACKET REPLACEMENT**

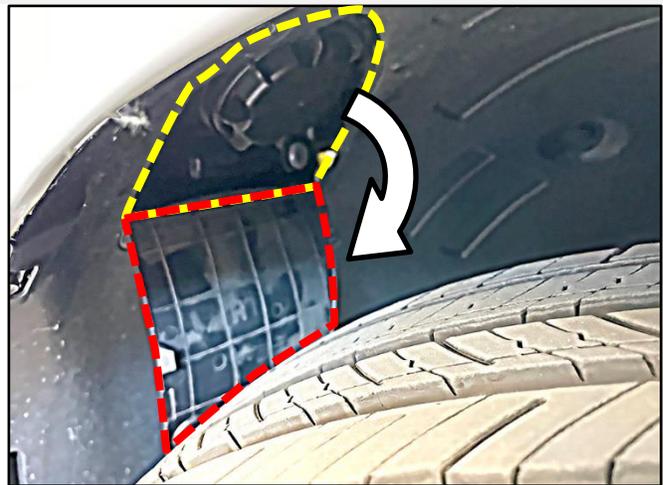
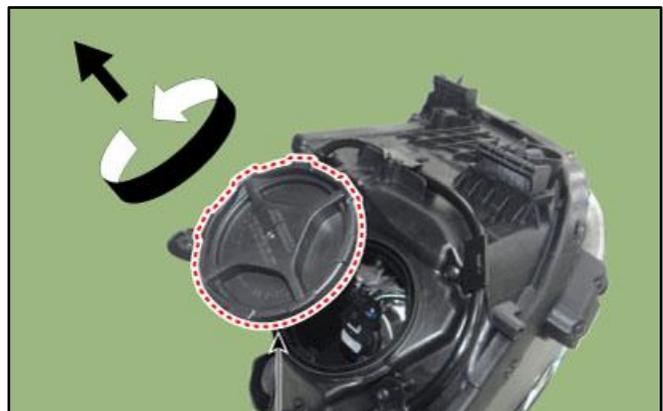
**Note:** The service cover is located on the inner fender liner. Remove the clip at the top of the cover, then fold down as shown to access the dust cover.

Do **NOT** remove the rivets at the bottom of the service cover.

1. Replace the moisture absorbent and bracket on both sides with the new parts by referring to the “Body Electrical System → Lighting System → Headlamps → Repair procedures → Replacement → Moisture Absorbent” chapter in the applicable Shop Manual on KGIS.

Even if only one of the DTCs is found (active or pending), the moisture absorbent and bracket must be replaced on **BOTH** sides.

2. Reassemble all removed parts in reverse order of disassembly.
3. Clear DTCs and confirm normal operation of the Dynamic Bending Light.
4. Discard the old bracket and moisture absorbent.
